Manhole Inspection Summary

Manhole # S31I__011MH

Insp Date: **11/20/08 9:39 AM**

Location Address: **22 w lombard**

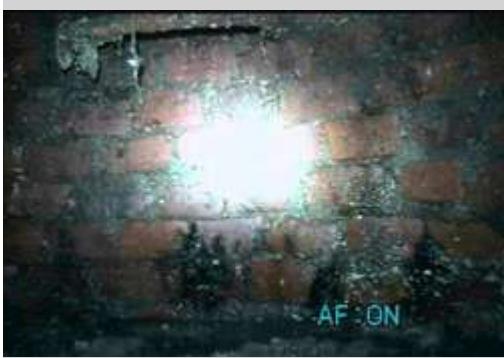
Defect 3

Infiltration: ☐ None ☐ Joint ☐ Cracks ☐ Mortar ☐ Roots ☒ **Wall**

Surcharge ☒ **Evidence Of Surcharge** Depth: **3** (ft.) ☐ Active Surcharge Present

Infiltration in Barrel, Surcharge Evidence

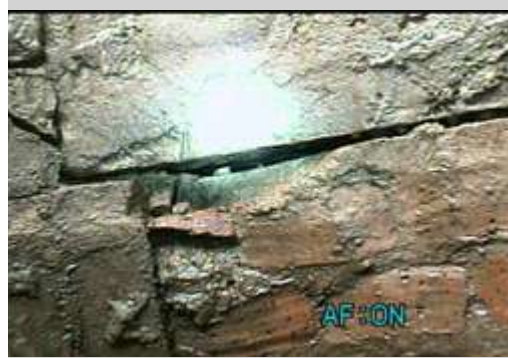
Defect 2

Condition: ☐ Sound ☒ **Cracked** ☐ Root Intrusion ☐ Loose Brick ☒ **Deteriorated**

Infiltration: ☐ None ☐ Joint ☐ Cracks ☐ Mortar ☐ Roots ☒ **Wall**

Cracked Corbel, Corbel Infiltration

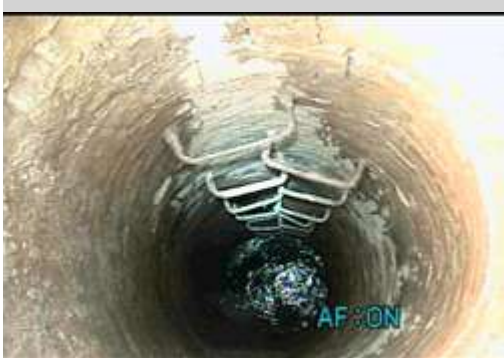
Defect 1

Infiltration: ☐ None ☒ **Joint** ☐ Cracks ☐ Mortar ☐ Roots ☐ Wall

Steps Count: **15** Missing: **0** ☒ **Corroded**

cor. steps, chimney infiltration (mud deposits)

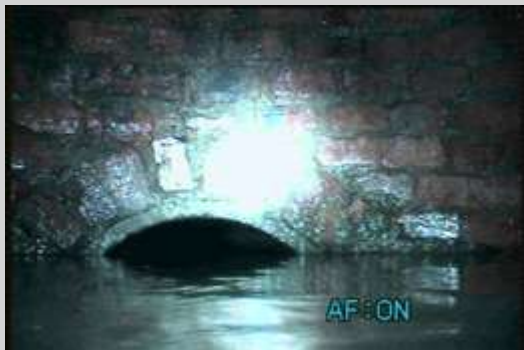
12 O'Clock Outflow

15 in. Circular Gravity Sewer
Pipe Out @ 12 O'Clock

Invert Depth: **22.80** (ft.) Flow Characteristics: **Slow**

Infiltration: **None** Pipe Seal Cond: **Unknown**

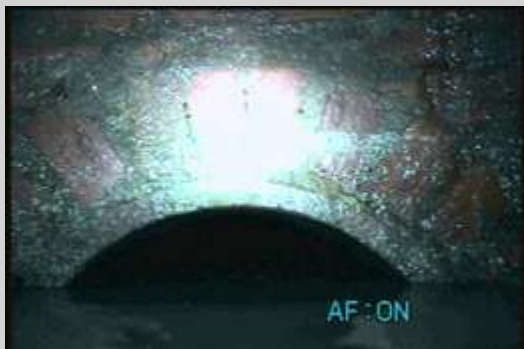
6 O'Clock Inflow

15 in. Circular Gravity Sewer
Pipe In @ 6 O'Clock

Invert Depth: **22.66** (ft.) Flow Characteristics: **Slow**

Infiltration: **None** Pipe Seal Cond: **Unknown**
